Manhole Inspection Summary

Manhole # S06YY1013MH

Location Address: **4014 CLARKS LN** Cross Street: **REISTERSTOWN RD**

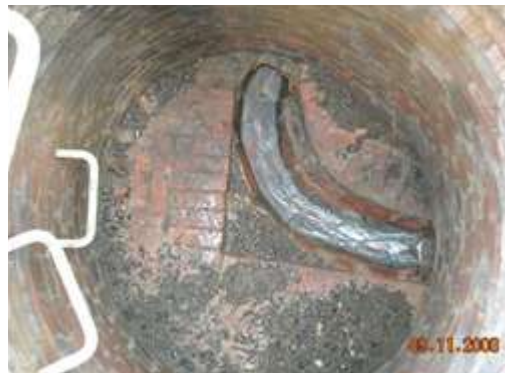
Top View

Bench debris.

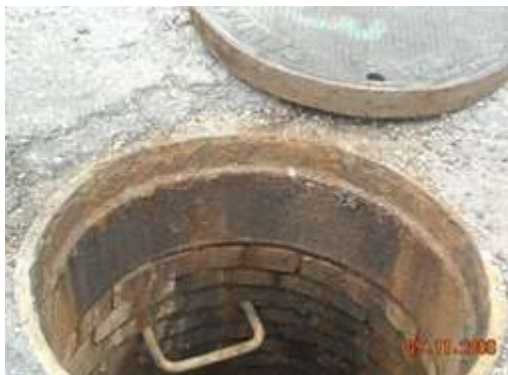
Defect

Frame Offset: **0** (in.) Condition: ☐ Sound ☐ Cracked ☒ **Leaks**

Corbel Material: **Brick** ☐ Parged Type: **Concentric/Eccentric**
Condition: ☐ Sound ☐ Cracked ☐ Root Intrusion ☐ Loose Brick ☒ **Deteriorated**
Infiltration: ☐ None ☒ **Joint** ☐ Cracks ☒ **Mortar** ☐ Roots ☐ Wall

Frame leaks. Corbel deterioration and infiltration.

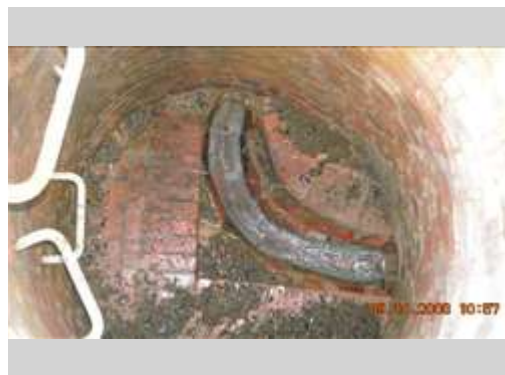
Defect

Barrel Material: **Brick** ☐ Parged
Shape: **Circular** Diameter: **42** (in.) Length: (in.)
Condition: ☒ Sound ☐ Cracked ☐ Root Intrusion ☐ Loose Brick ☐ Deteriorated
Infiltration: ☐ None ☐ Joint ☐ Cracks ☒ **Mortar** ☐ Roots ☒ **Wall**

Barrel infiltration.

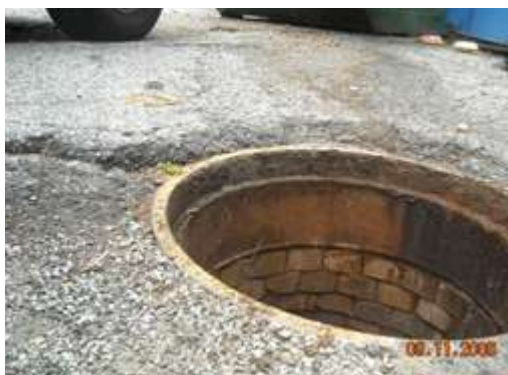
Defect

Below grade.

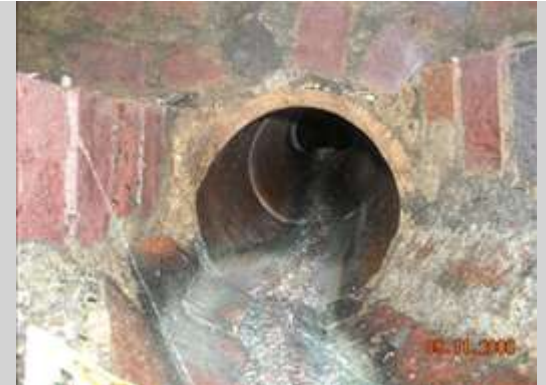
8 in. Circular Gravity Sewer Pipe Out @ 12 O'Clock

Infiltration: **Evidence** Pipe Seal Cond: **Unknown**
